REPORT NO.: 10
TESTING OF EXTRUDED FLEXIBLE uPVC GUIDE POSTS

KEY WORDS: **Testing Guide Posts**

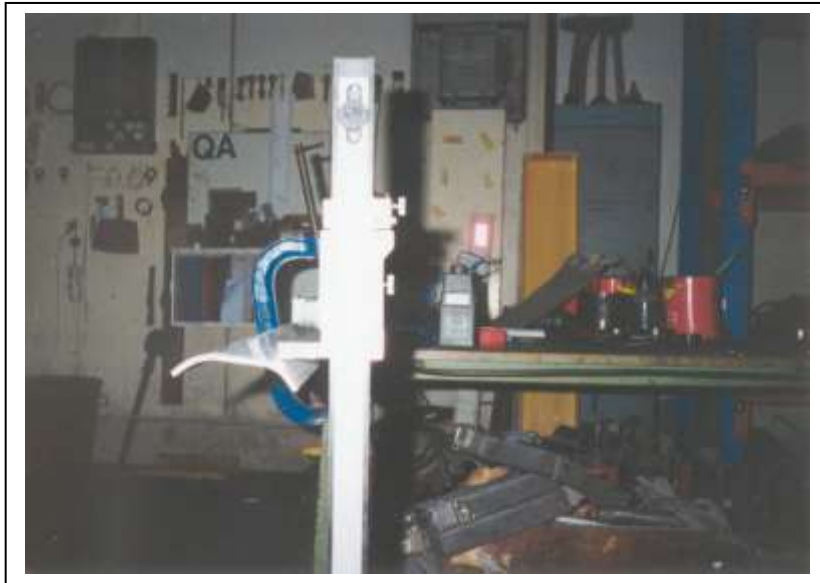
Photograph #1. *Vernier Height Gauge at rest on sample post, ambient temp 23°C*

Mitutoyo Vernier Height Gauge Cat. No 520-163 (Photograph #1)

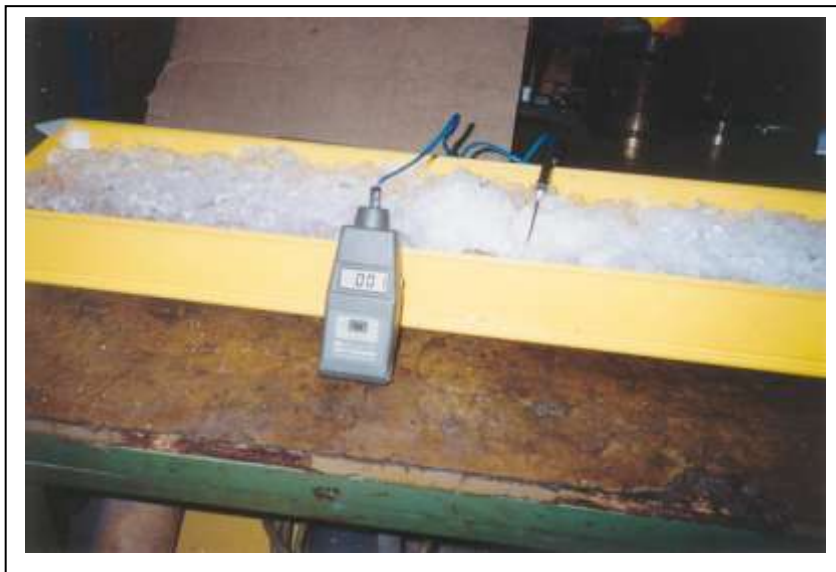
Photograph #2. *Digital Thermometer / Ice Bath Unit*

Lutron TM-901C Digital Thermometer with TP-02A probe (Photo #2)

Ice Bath 95 mm x 230 mm x 1700 (14 kgs ice) (Photo #2 Temp probe exposed)

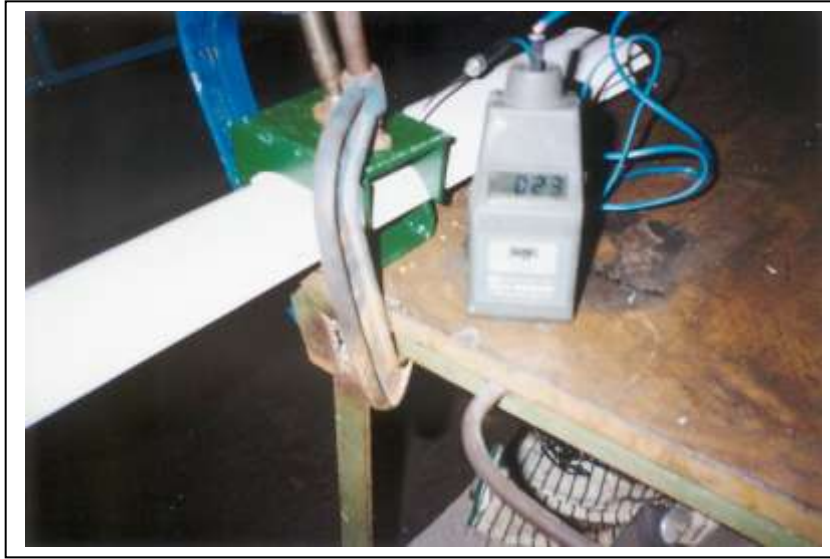
Photograph #3. *Guide Post two-part anchor and G Clamps*

Guidepost shaped two-part anchor unit (Photograph #3)

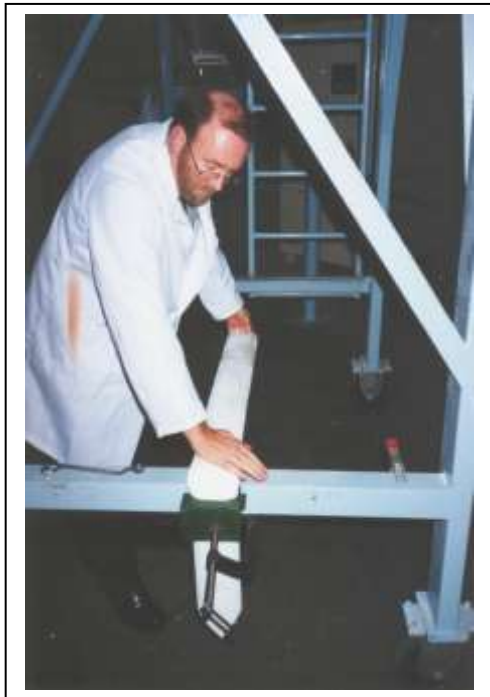
Photograph #4.
Vertical Mounting Frame

Steel vertical mounting frame (Photograph #4)

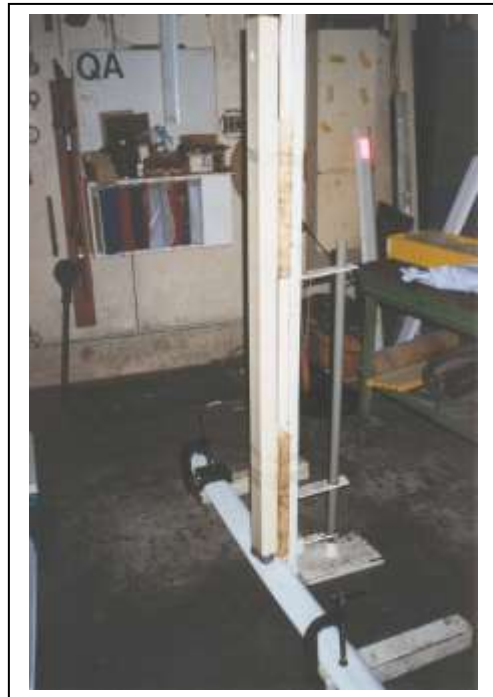
Photograph #5.
Impact resistance Testing Unit

Impact Resistance testing unit with 1500 mm low friction guide (Photo #5)
